Flood Control Project Maintenance
Levee Inspections

Fall 2012 Levee Maintenance Deficiency Summary Report

Reclamation District No. 0544 Upper Roberts Island

Levee Inspection Report By Mile - Fall 2012

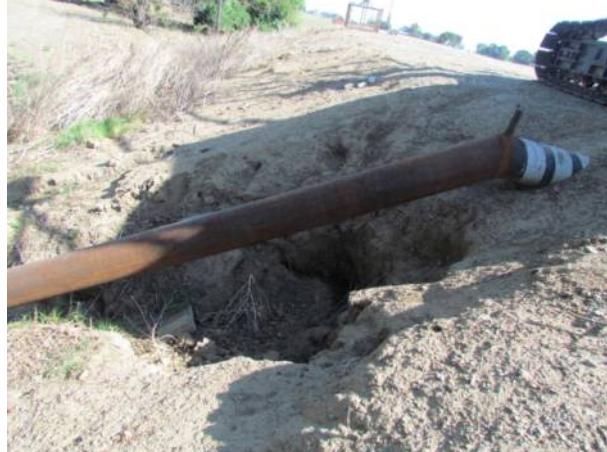
Levee Mile Report Line	26
Start Levee Mile	2.28
End Levee Mile	2.28
Location	Land Side
Category	Earthen Levee
Item	Erosion / Bank Caving
Looking north at erosion under irrigation pipe on landside slope.	
richard_f_20121012_442.jpg

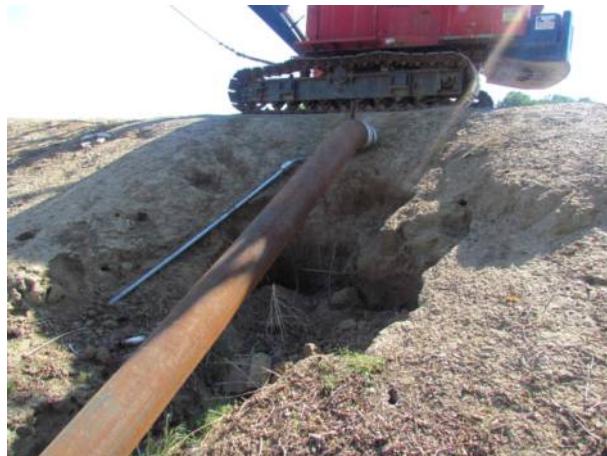
Levee Mile Report Line	26
Start Levee Mile	2.28
End Levee Mile	2.28
Location	Land Side
Category	Earthen Levee
Item	Erosion / Bank Caving
Looking east at erosion under irrigation pipe on landside slope.	
richard_f_20121012_443.jpg

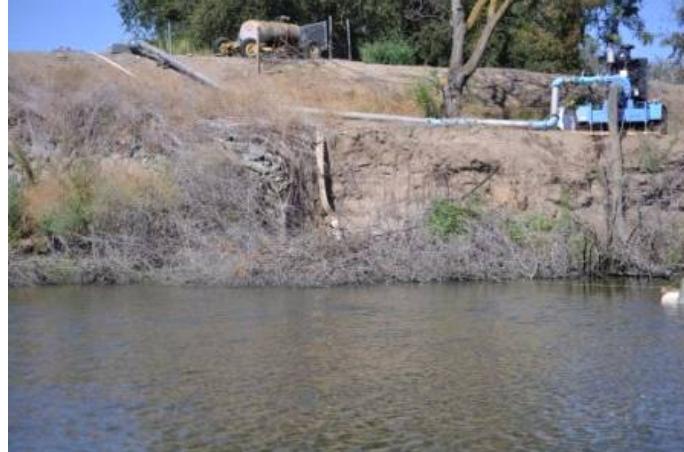
Levee Mile Report Line	32
Start Levee Mile	2.94
End Levee Mile	2.94
Location	Water Side
Category	Supplemental
Item	DWR Erosion Survey
Front view of the site. Note the dense vegetation and rocks immediately upstream of the erosion	SJR2012_RD0544U01RM49.67_2.jpg

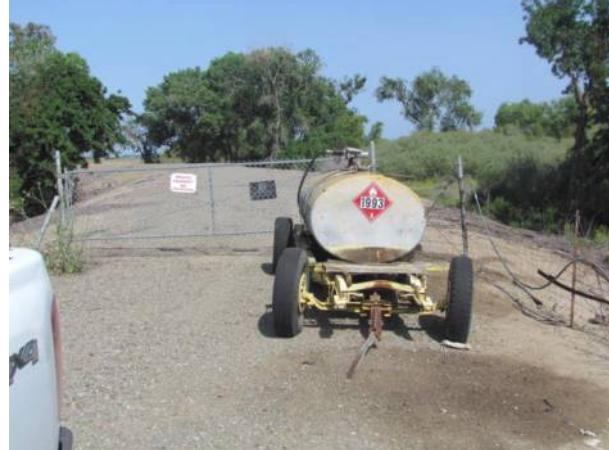
Levee Mile Report Line	34
Start Levee Mile	2.98
End Levee Mile	2.98
Location	Land Side
Category	Earthen Levee
Item	Encroachments
Looking north at diesel tank on waterside shoulder in front of gate.(Spring 2012)	
richard_f_20121012_438.jpg

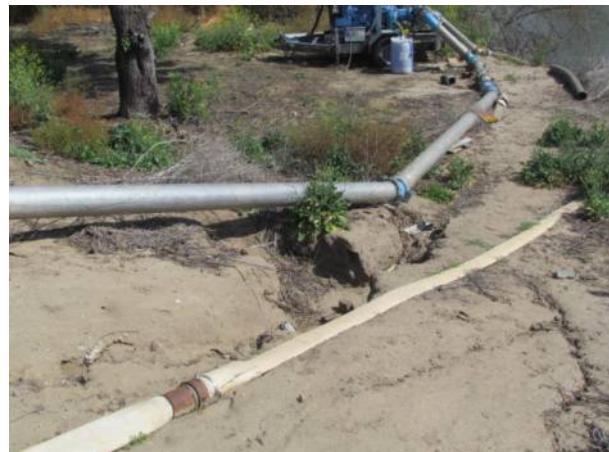
Levee Mile Report Line	34
Start Levee Mile	2.98
End Levee Mile	2.98
Location	Land Side
Category	Earthen Levee
Item	Encroachments
Looking northeast at unauthorized pump system on waterside slope.	
richard_f_20121012_439.jpg

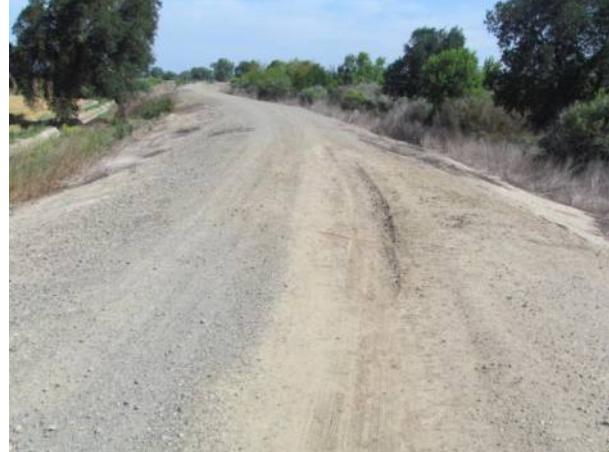
Levee Mile Report Line	43
Start Levee Mile	3.97
End Levee Mile	4.34
Location	Crown
Category	Earthen Levee
Item	Crown Surface / Depressions / Rutting
Looking south at one of several sites needing gravel or road base on levee crown.	
richard_f_20121012_456.jpg

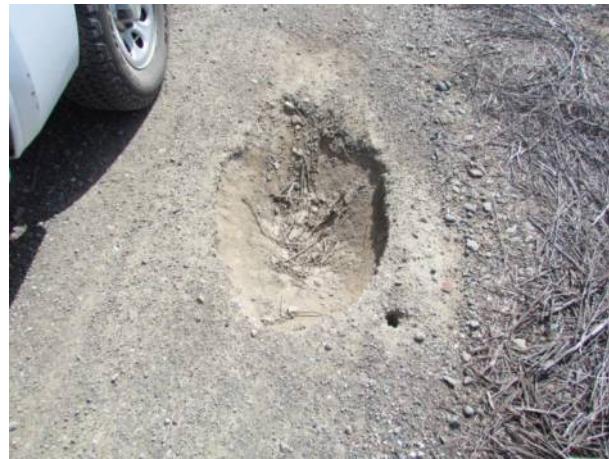
Levee Mile Report Line	46
Start Levee Mile	4.20
End Levee Mile	4.20
Location	Crown
Category	Earthen Levee
Item	Erosion / Bank Caving
Looking north at sink hole on levee crown near waterside shoulder.	
richard_f_20121012_429.jpg

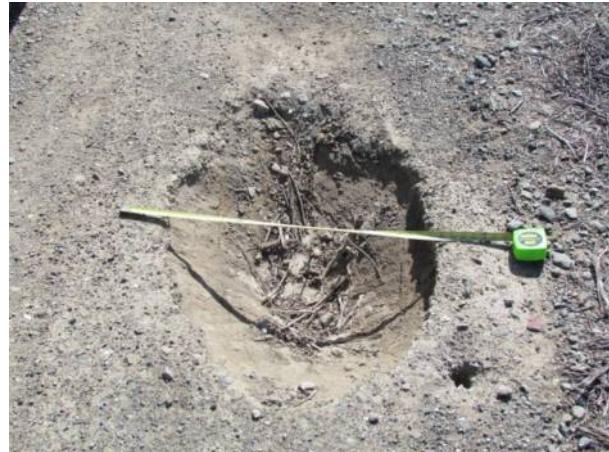
Levee Mile Report Line	46
Start Levee Mile	4.20
End Levee Mile	4.20
Location	Crown
Category	Earthen Levee
Item	Erosion / Bank Caving
Looking north at sink hole on crown near waterside shoulder.	
richard_f_20121012_431.jpg

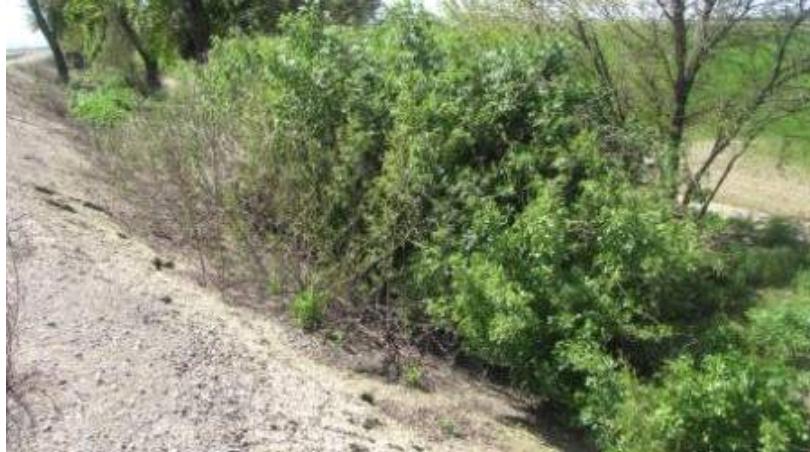
Levee Mile Report Line	53
Start Levee Mile	4.53
End Levee Mile	4.53
Location	Land Side
Category	Earthen Levee
Item	Vegetation
Looking south at elderberries on landside slope and toe.	
richard_f_20121012_447.jpg

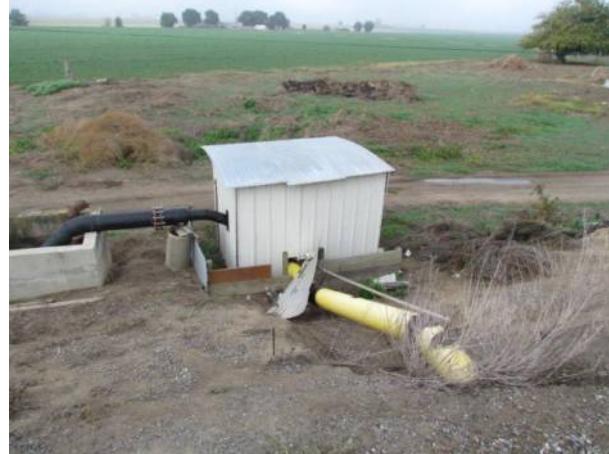
Levee Mile Report Line	58
Start Levee Mile	4.78
End Levee Mile	4.78
Location	Land Side
Category	Earthen Levee
Item	Encroachments
Looking west at a unauthorized pump house on landside toe.	
richard_f_20121012_448.jpg

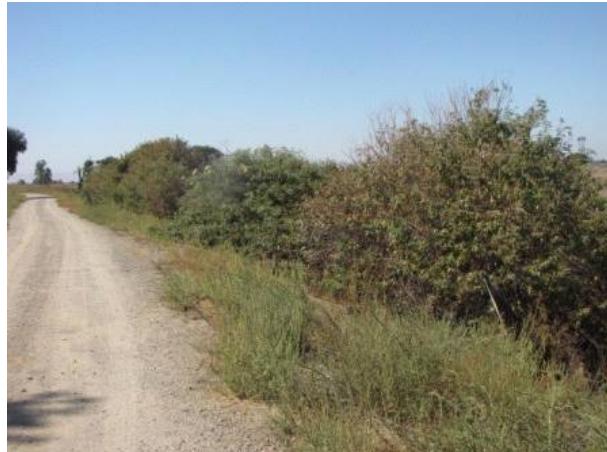
Levee Mile Report Line	66
Start Levee Mile	5.54
End Levee Mile	5.60
Location	Land Side
Category	Earthen Levee
Item	Vegetation
Looking southwest on elderberries on landside slope and toe.	
richard_f_20121012_440.jpg

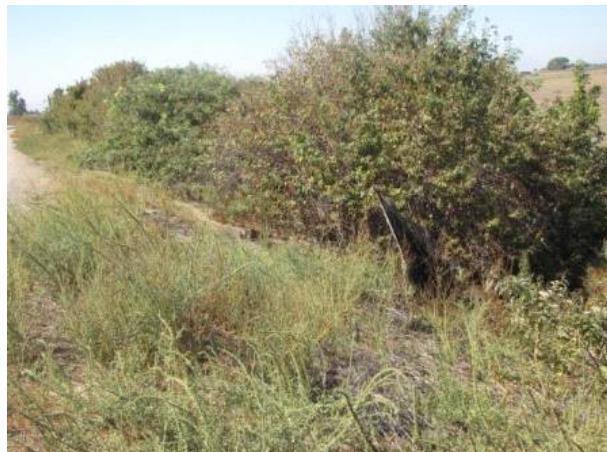
Levee Mile Report Line	66
Start Levee Mile	5.54
End Levee Mile	5.60
Location	Land Side
Category	Earthen Levee
Item	Vegetation
Looking south at elderberries on landside slope and toe.	
richard_f_20121012_441.jpg

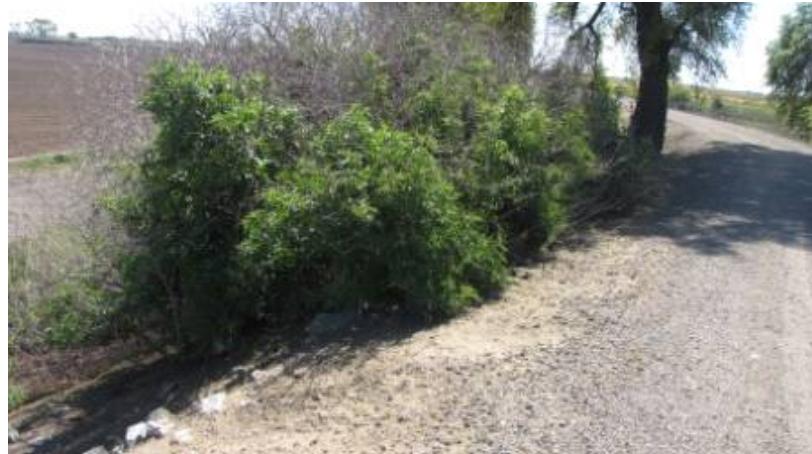
Levee Mile Report Line	2
Start Levee Mile	0.41
End Levee Mile	0.41
Location	Land Side
Category	Earthen Levee
Item	Vegetation
Looking northwest at elderberries on landside slope and toe.	
richard_f_20121012_458.jpg

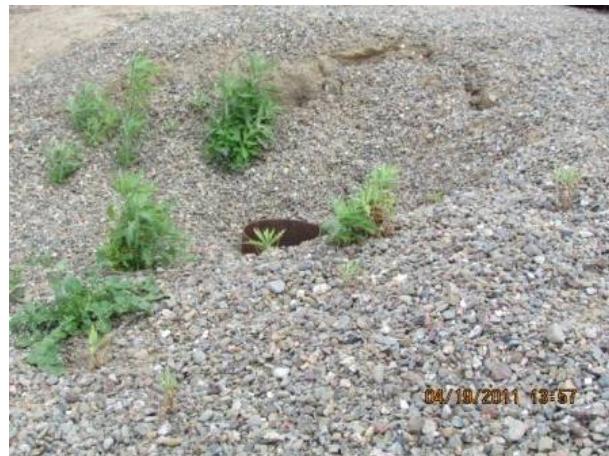
Levee Mile Report Line	7
Start Levee Mile	0.79
End Levee Mile	0.79
Location	Water Side
Category	Interior Drainage & Piping Systems
Item	Erosion Areas
Looking south at depression greater than 6" around siphon on waterside shoulder.	
richard_f_20121012_466.jpg

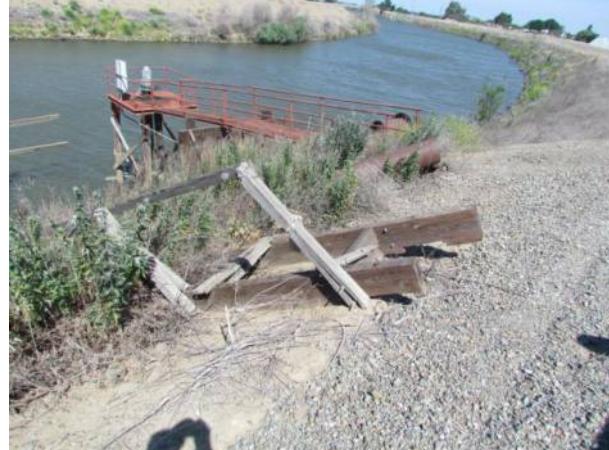
Levee Mile Report Line	8
Start Levee Mile	1.02
End Levee Mile	1.02
Location	Water Side
Category	Earthen Levee
Item	Encroachments
Looking southeast at garbage on waterside shoulder and slope.	
richard_f_20121012_462.jpg

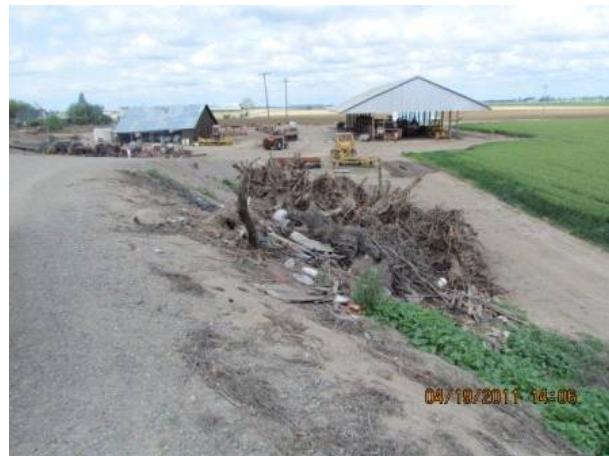
Levee Mile Report Line	9
Start Levee Mile	1.14
End Levee Mile	1.14
Location	Land Side
Category	Earthen Levee
Item	Encroachments
Looking southwest at pruning pile on landside slope.	
richard_f_20121012_485.jpg

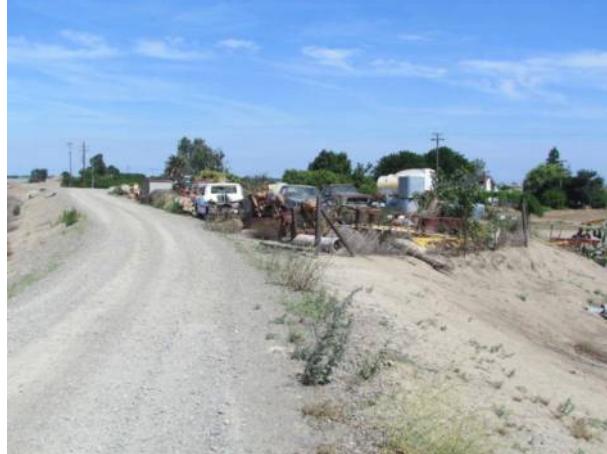
Levee Mile Report Line	11
Start Levee Mile	1.17
End Levee Mile	1.23
Location	Land Side
Category	Earthen Levee
Item	Encroachments
Looking southwest at vehicles and farm equipment stored on landside landing.	
richard_f_20121012_480.jpg

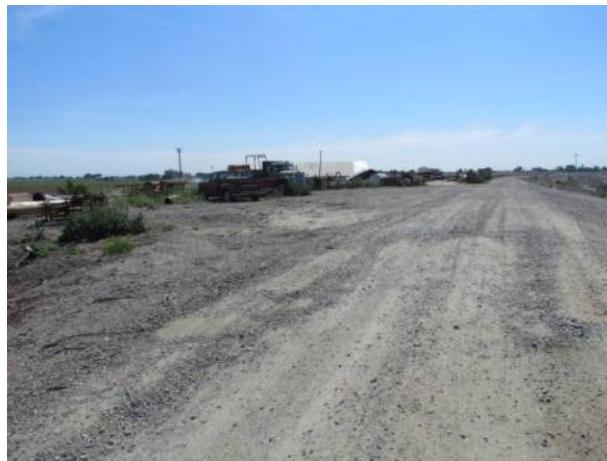
Levee Mile Report Line	11
Start Levee Mile	1.17
End Levee Mile	1.23
Location	Land Side
Category	Earthen Levee
Item	Encroachments
Looking northwest at vehicles and farm equipment stored on landside landing.	
richard_f_20121012_481.jpg

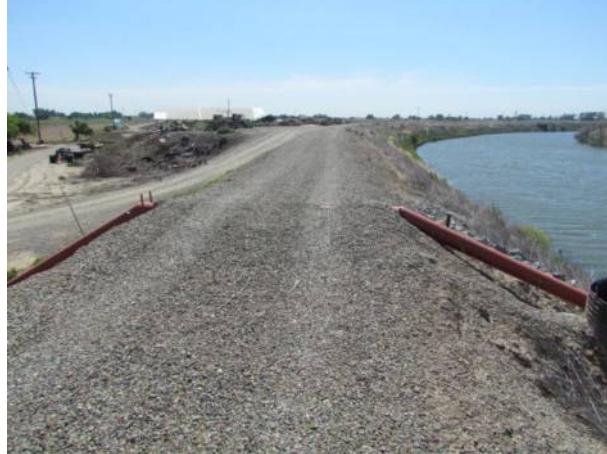
Levee Mile Report Line	13
Start Levee Mile	1.26
End Levee Mile	1.26
Location	Crown
Category	Earthen Levee
Item	Encroachments
Looking north at covering and ramp over irrigation pipe.	
richard_f_20121012_482.jpg

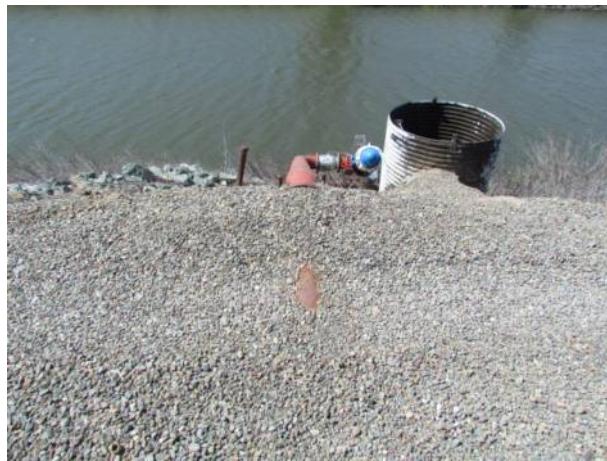
Levee Mile Report Line	13
Start Levee Mile	1.26
End Levee Mile	1.26
Location	Crown
Category	Earthen Levee
Item	Encroachments
Looking east at ramp over irrigation pipe.	
richard_f_20121012_483.jpg

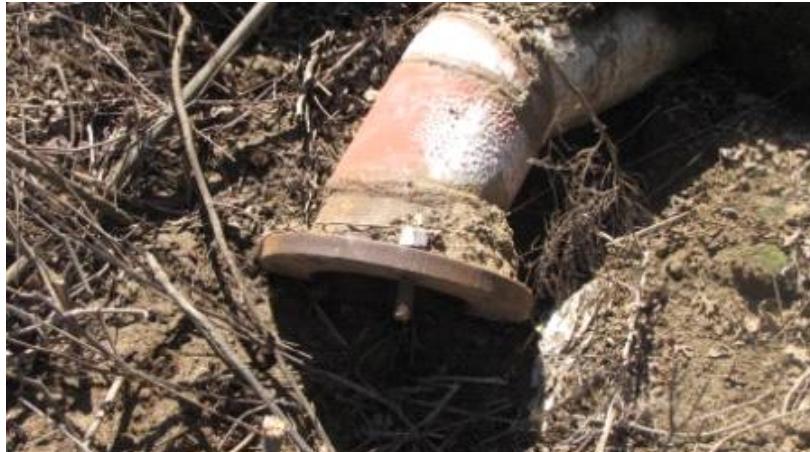
richard_f_20121012_487.jpg

Looking east at pipe on landside slope.

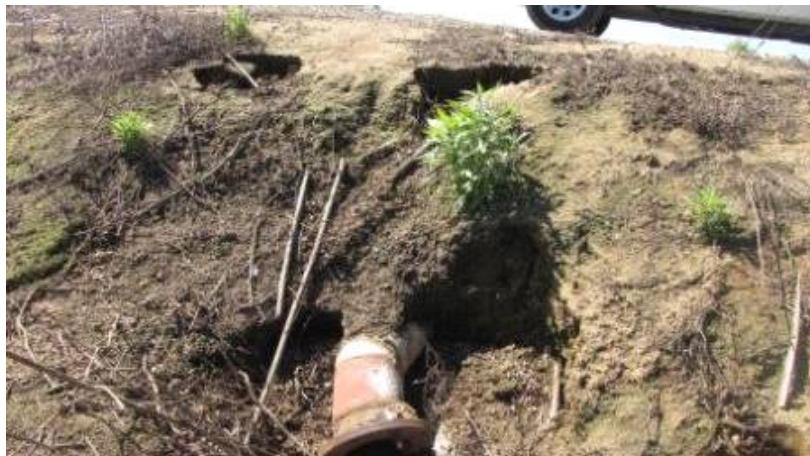
richard_f_20121012_488.jpg

Levee Mile Report Line	16
Start Levee Mile	1.40
End Levee Mile	1.40
Location	Land Side
Category	Earthen Levee
Item	Encroachments

Looking east at pipe and erosion just above pipe on landside slope and shoulder.

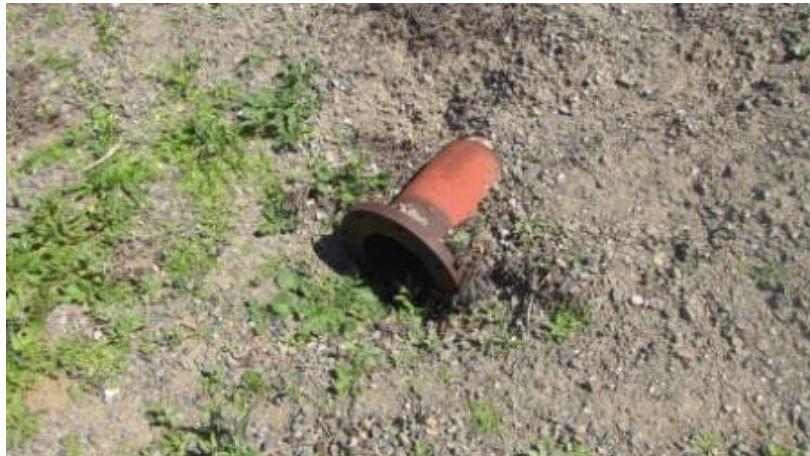
richard_f_20121012_489.jpg

Levee Mile Report Line	16
Start Levee Mile	1.40
End Levee Mile	1.40
Location	Land Side
Category	Earthen Levee
Item	Encroachments

Looking west at east end of pipe on waterside slope.

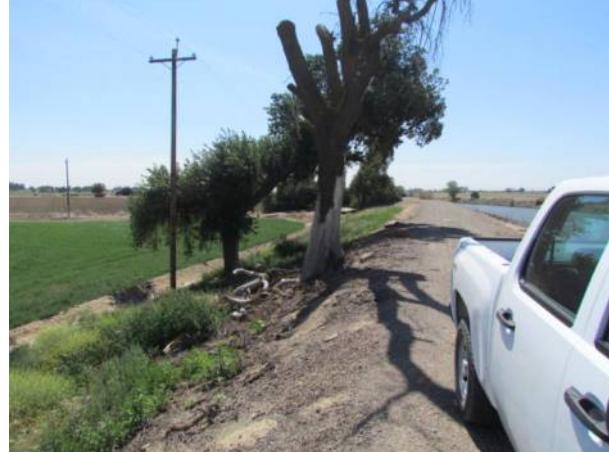
Levee Mile Report Line	20
Start Levee Mile	1.48
End Levee Mile	1.48
Location	Land Side
Category	Earthen Levee
Item	Encroachments
Looking north at dead tree and tree limbs on landside shoulder and slope.	
richard_f_20121012_491.jpg

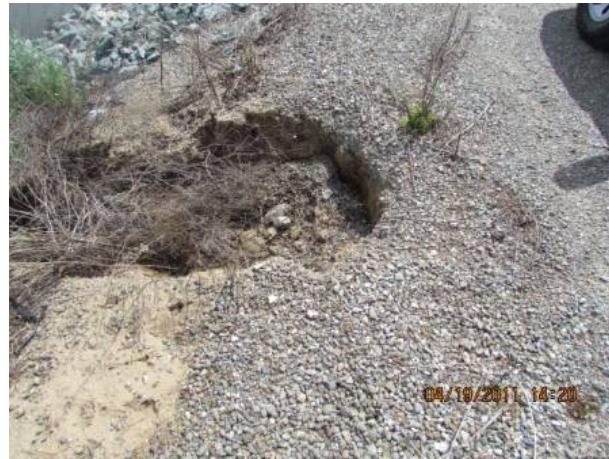
Levee Mile Report Line	22
Start Levee Mile	1.89
End Levee Mile	1.89
Location	Water Side
Category	Earthen Levee
Item	Slope Stability
Looking southeast at depression greater than 6" and slope stability on waterside shoulder and slope.	
richard_f_20121012_475.jpg

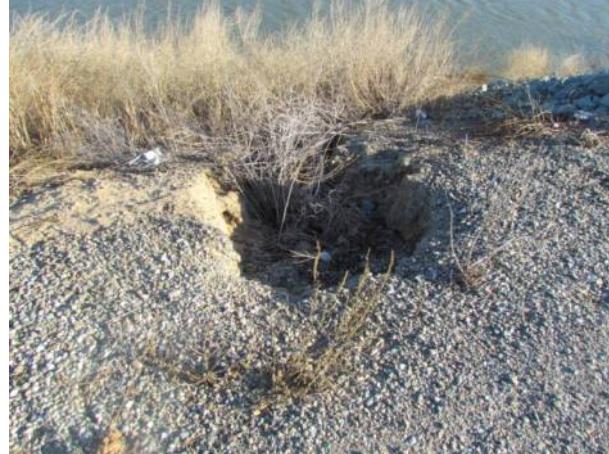
Levee Mile Report Line	22
Start Levee Mile	1.89
End Levee Mile	1.89
Location	Water Side
Category	Earthen Levee
Item	Slope Stability
Looking east at caving on waterside shoulder. (Fall Inspection)	
richard_f_20121012_477.jpg

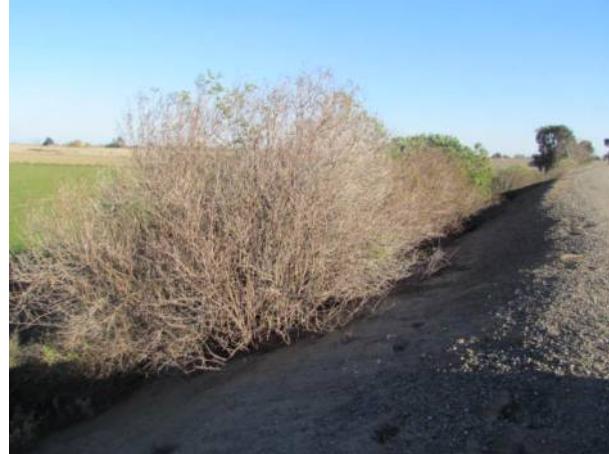
Levee Mile Report Line	25
Start Levee Mile	2.11
End Levee Mile	2.12
Location	Land Side
Category	Earthen Levee
Item	Vegetation
Looking northwest at elderberries on landside slope and toe.	
richard_f_20121012_473.jpg

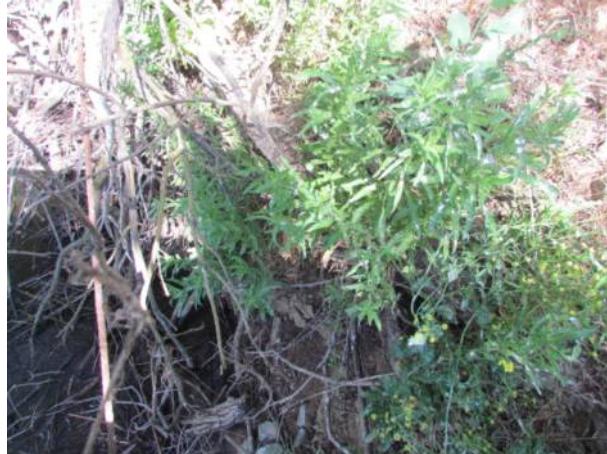
Levee Mile Report Line	30
Start Levee Mile	2.35
End Levee Mile	2.35
Location	Water Side
Category	Channels
Item	Erosion / Bank Caving
Looking south at breaver hole at waterside toe.	
richard_f_20121012_492.jpg

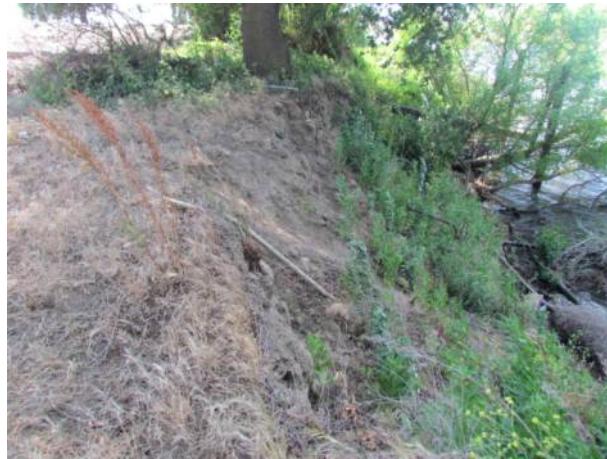
Levee Mile Report Line	30
Start Levee Mile	2.35
End Levee Mile	2.35
Location	Water Side
Category	Channels
Item	Erosion / Bank Caving
Looking north at erosion on waterside slope.	
richard_f_20121012_493.jpg

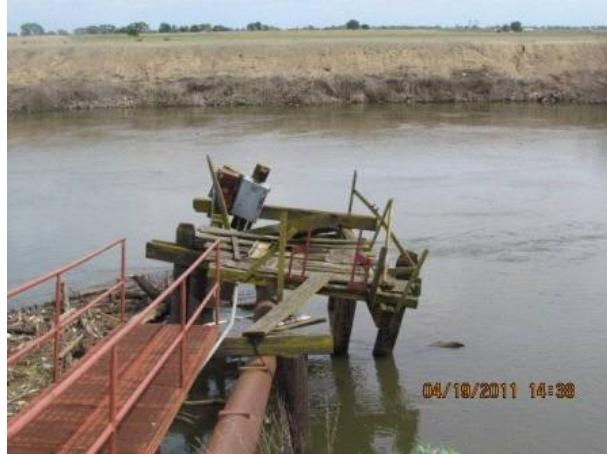
Levee Mile Report Line	33
Start Levee Mile	2.64
End Levee Mile	2.64
Location	Water Side
Category	Channels
Item	Encroachments
Looking east at dilapidated pump platform.	
<i>richard_f_20121012_479.jpg</i>

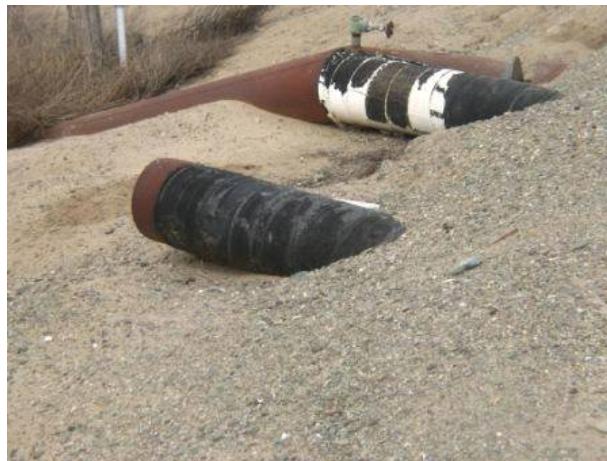
Levee Mile Report Line	34
Start Levee Mile	2.65
End Levee Mile	2.65
Location	Crown
Category	Earthen Levee
Item	Encroachments
Abandoned pipe at LM 2.65, landside view.	
<i>richard_f_20121012_474.jpg</i>

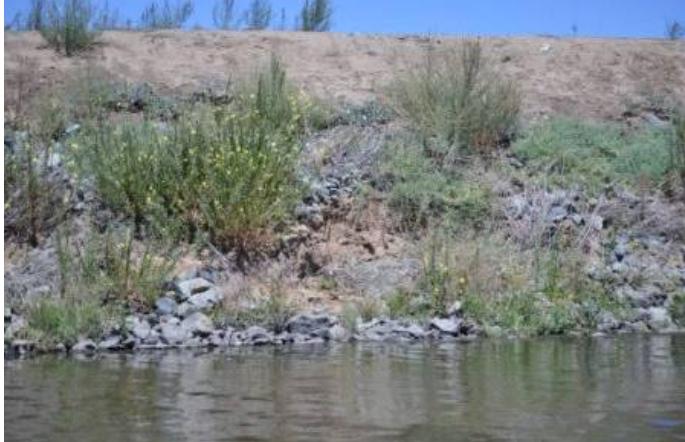
SJR2012_RD0544U02RM32.91_2.jpg

Levee Mile Report Line	35
Start Levee Mile	2.65
End Levee Mile	2.67
Location	Water Side
Category	Supplemental
Item	DWR Erosion Survey

Front view of pocket erosion

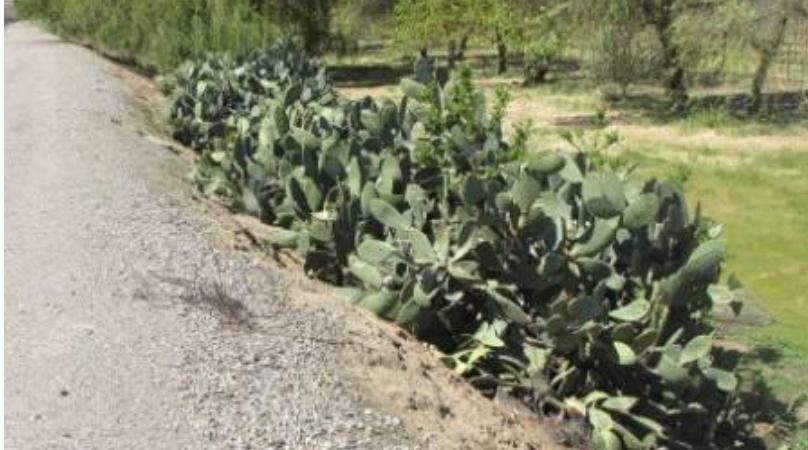
richard_f_20121012_495.jpg

Levee Mile Report Line	37
Start Levee Mile	3.53
End Levee Mile	3.56
Location	Land Side
Category	Earthen Levee
Item	Vegetation

Looking southwest at overgrown cactus on landside slope.

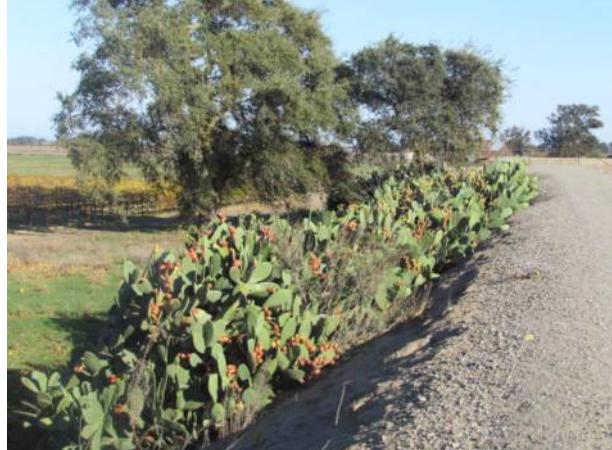
richard_f_20121012_496.jpg

Levee Mile Report Line	37
Start Levee Mile	3.53
End Levee Mile	3.56
Location	Land Side
Category	Earthen Levee
Item	Vegetation

Looking north at cactus on landside slope and toe.
